BLACKSTONE RIVER BASIN
GRAFTON, MASSACHUSETTS

FISHERVILLE POND DAM
MA 00577

PHASE I INSPECTION REPORT NATIONAL DAM INSPECTION PROGRAM

OCTOBER 1978

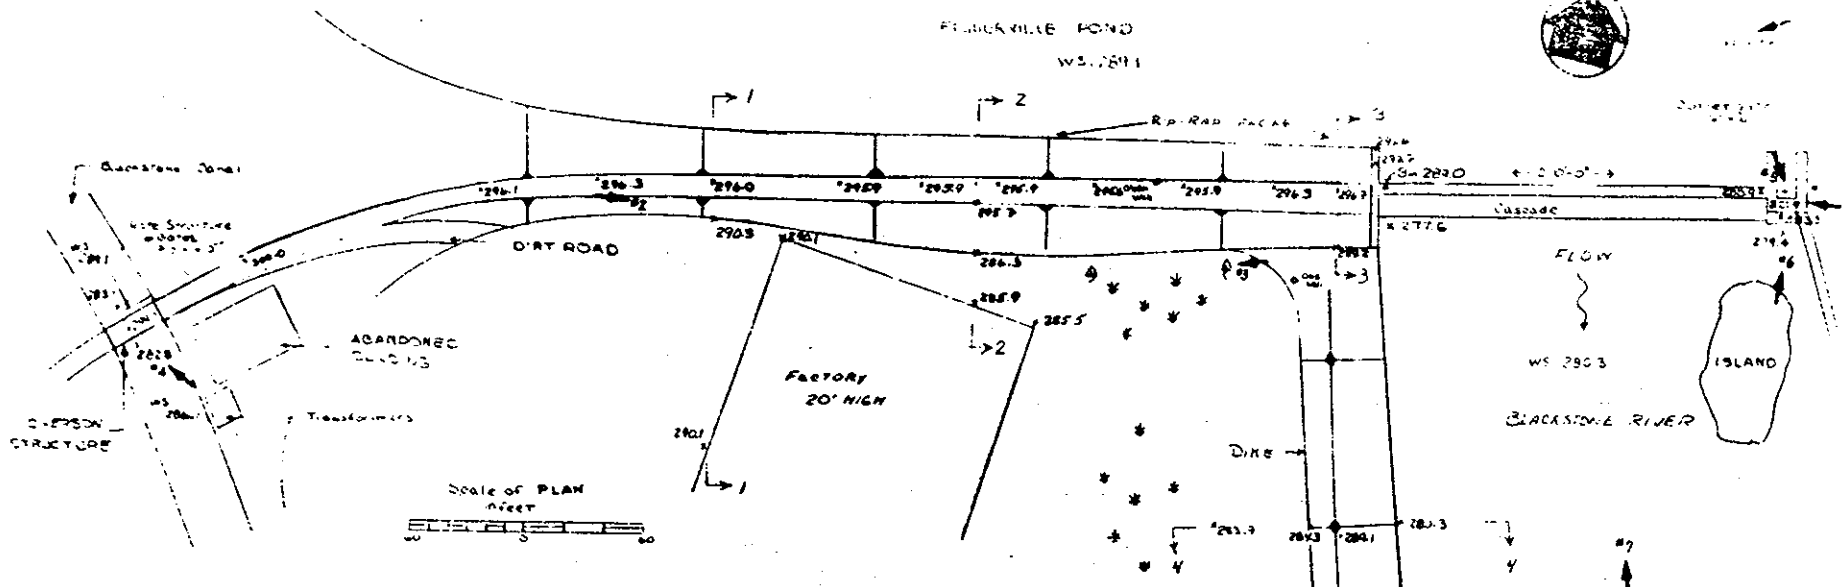
REGION 1	STATE 1	FEDERAL PROJECT NO. 1
NATIONAL PROGRAM OF INSPECTION OF DAMS		
FISHERVILLE POND DAM		
FIGURE D-1 PLAN OF DAM AND SECTIONS		
BLACKSTONE RIVER	MASSACHUSETTS	
SCALE: AS SHOWN	DATE: NOVEMBER, 1993

- NOTES:
- 1) Elevations shown based on assumed benchmark on Spillway Crest, E.L. 289.0 (M.S.L.)
 - 2) Information shown from field survey of Sept. 20, 1998
 - 3) A denotes seepage
 - 4) * denotes marshy land
 - 5) Plan of Dam and Sections are of different scales, 1"=60' and 1"=30' respectively
